Sludge Treatment Reed Bed Systems (STRB)

State of the art – 30 years of experience

Steen Nielsen Orbicon A/S Ringstedvej 20 DK – 4000 Roskilde

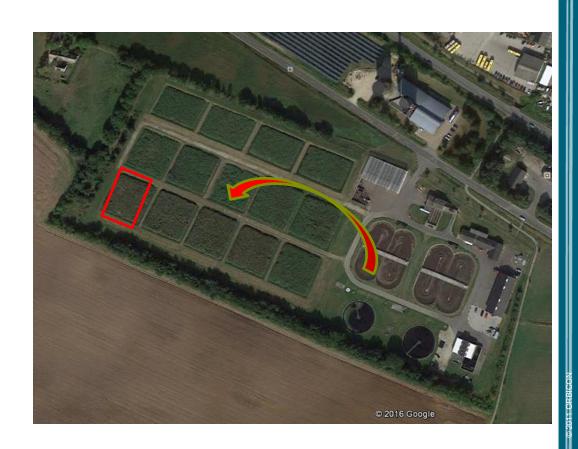
Helsinge Sludge Treatment Reed Bed Systems (STRB) – Denmark (1996 – 2017)

OPERATION

- STRB's are devided into a number of basins
- 630 tons ds activated sludge per year
- 14 Basins and Greenhouse stock pile area
 - 10 Basins (1996 into service)
 - 4 Basins (2013 into service)

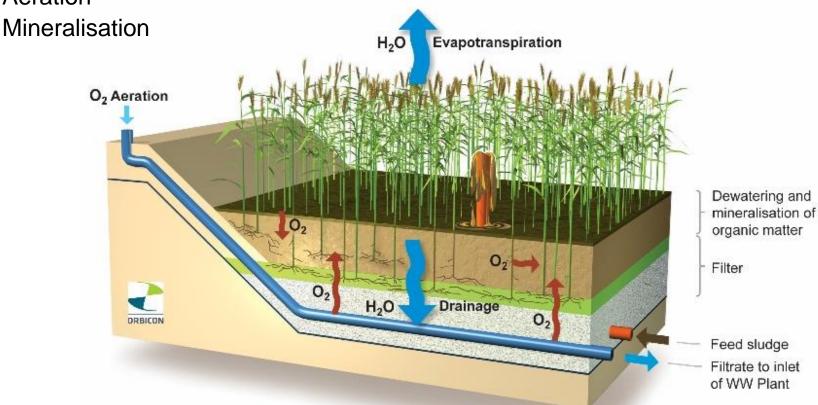
Long-term sludge reduction in reed beds Method - Overall funtionality

- Dewatering
 - Draining
 - Evapotranspiration

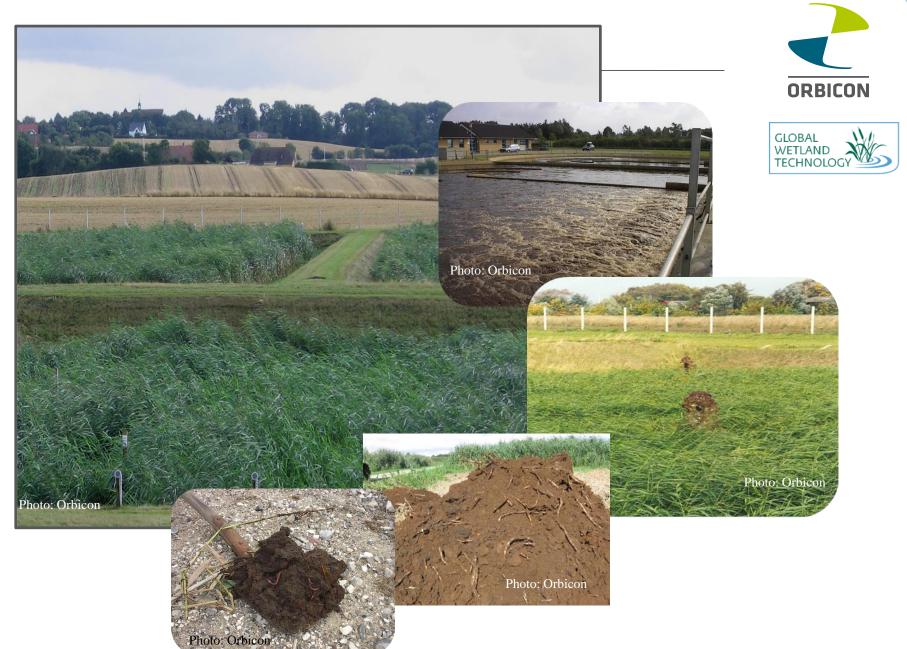
System Proces and Product

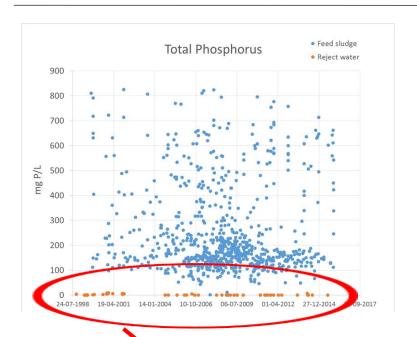
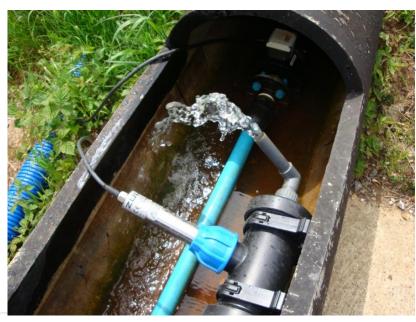
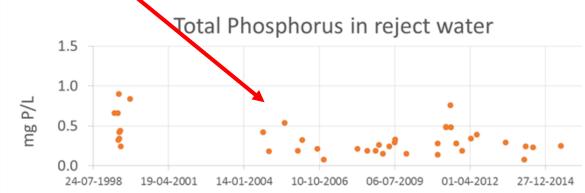
Filtrate quality

(Total P) from STRB systems treating activated sludge (1998 – 2017) – Chemical P removal (Ferric Sulfate) – Suspended solid

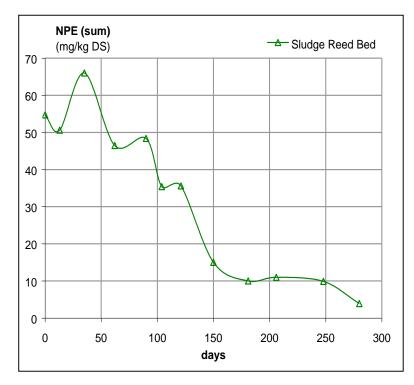
Mineralisation of digested sewage sludge Kallerup STRB (Denmark)

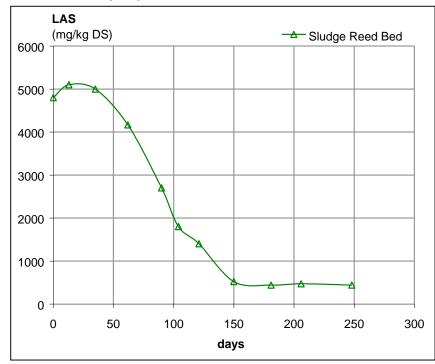
NPE (Nonyl Phenol Ethoxylate)

- Loaded mass (kg) 0.3
- Remaining mass (kg)0.02
- Reduction (%) 94

- LAS (Linear Alkylbenzene Sulfonate)
- Loaded mass (kg) 24.5
- Remaining mass (kg)0.4
- Reduction (%) 98

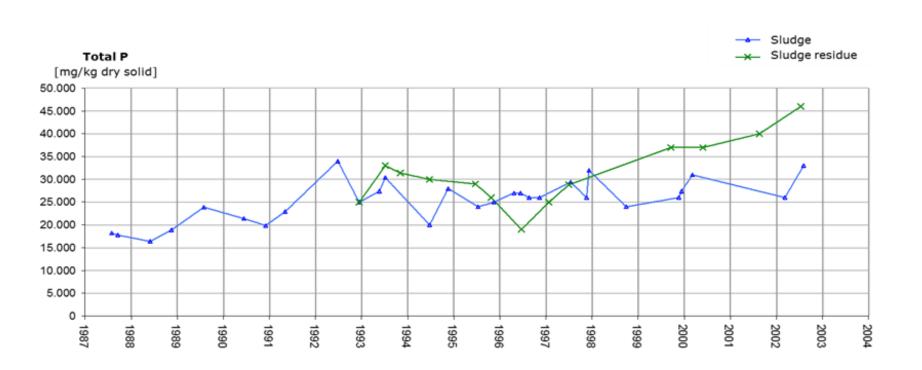
Accumulation of Total P in the Sludge residue (1997 – 2004)

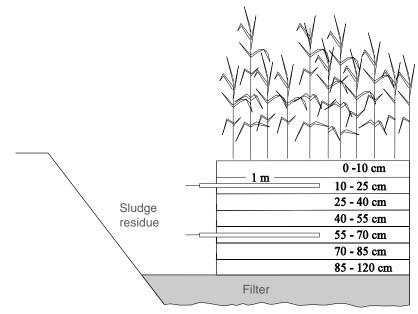
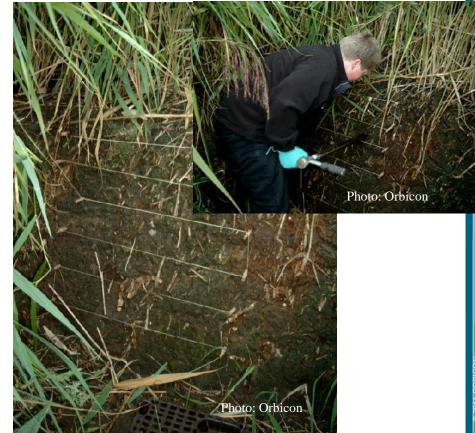
Reduction of pathogenic micro-organisms Section of sludge residue and sampling sites

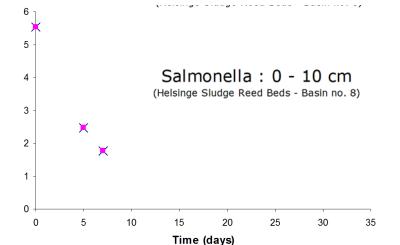
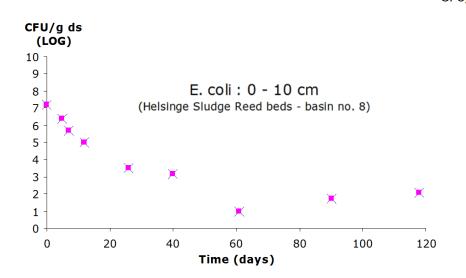
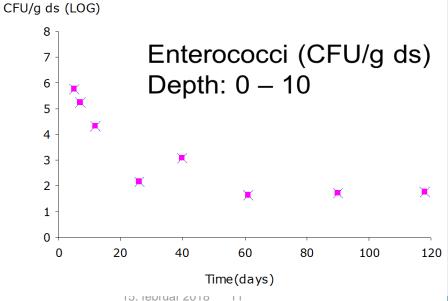
Reduction of pathogenic micro-organisms

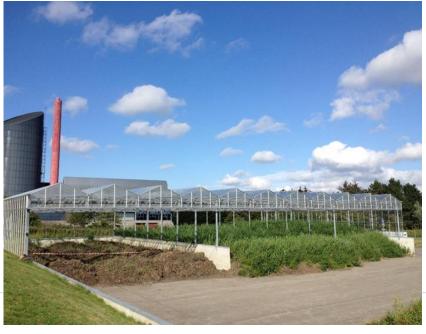
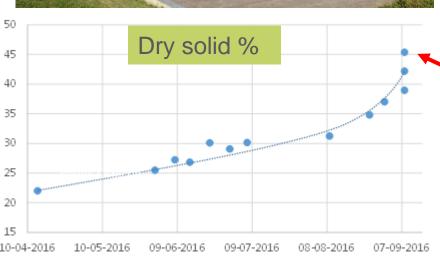
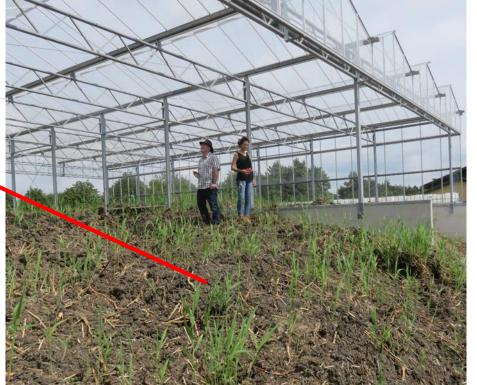
Helsinge STRB (Denmark) – Green house Solar drying of sewage sludge from STRB (2016 and 2017)

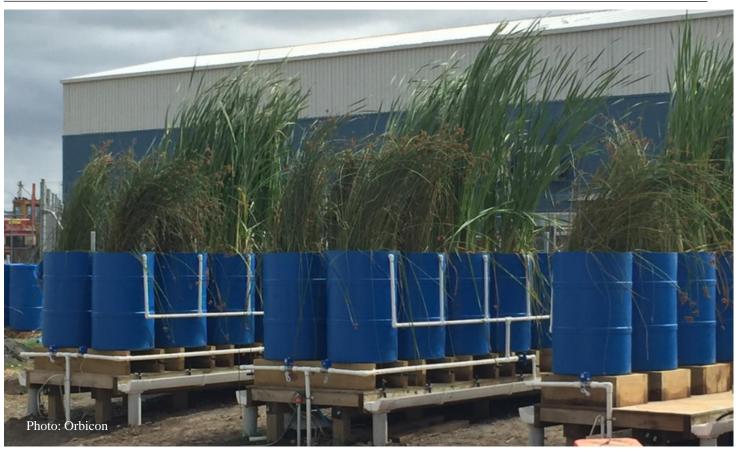
Gisborne Trial System (New Zealand) (2015 – 2016)

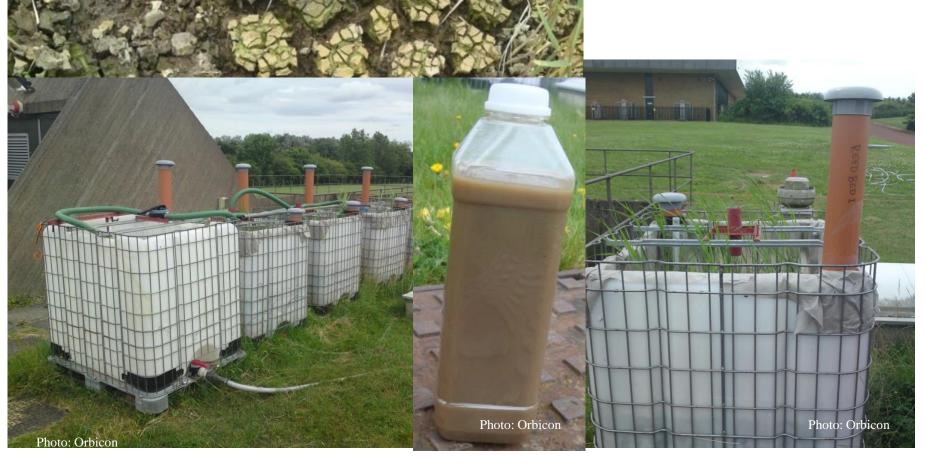
Lumley (England) – Alum Sludge (2009-2010) Pre-Test - Sludge Treatment Reed Bed System

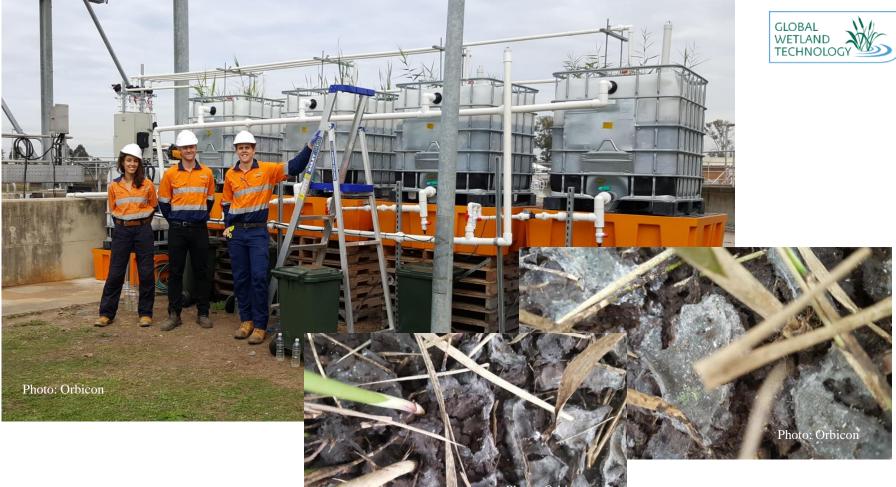
Wacol Trial (Australia) Sludge residue (2016 - 2018 - ?)

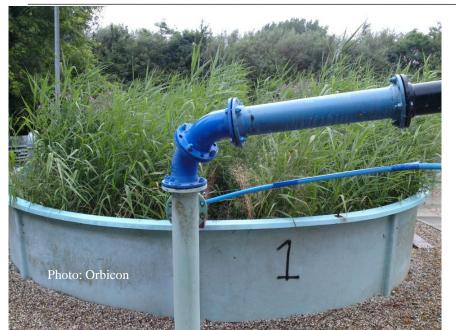
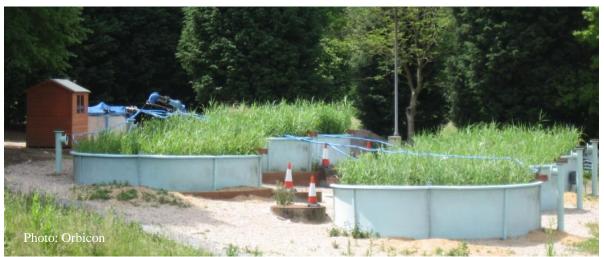
Hanningfield Water Work (England) 2008 – 2013, Trial (Water Works sludge - Iron)

6 basins / total 120 m²

(Planted in February 2008)
